RE: Property Condition Assessment (PCA)
 Summary Letter
 Orchard Hills
 5701 Orchard Street West
 Tacoma, Washington 98467
 CCG Project #: 3202

PROPERTY CONDITION REPORT

ORCHARD HILLS
5701 ORCHARD STREET WEST
TACOMA, PIERCE COUNTY, WASHINGTON 98467
PROJECT NUMBER: CCG-3202

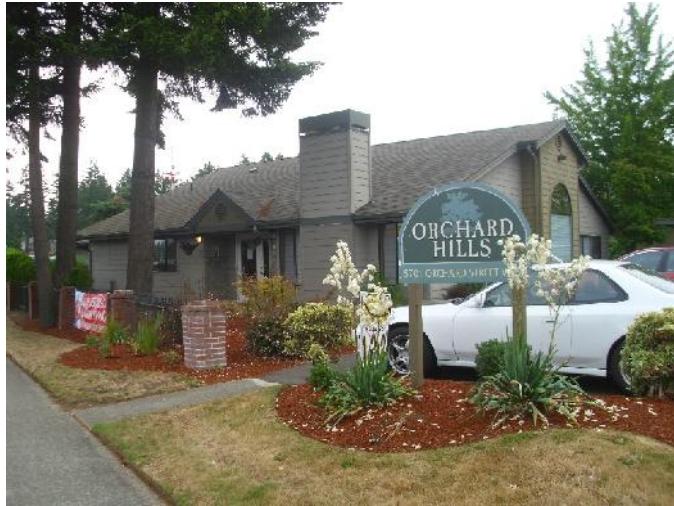
01 View of main Property sign, leasing office and representative landscaping

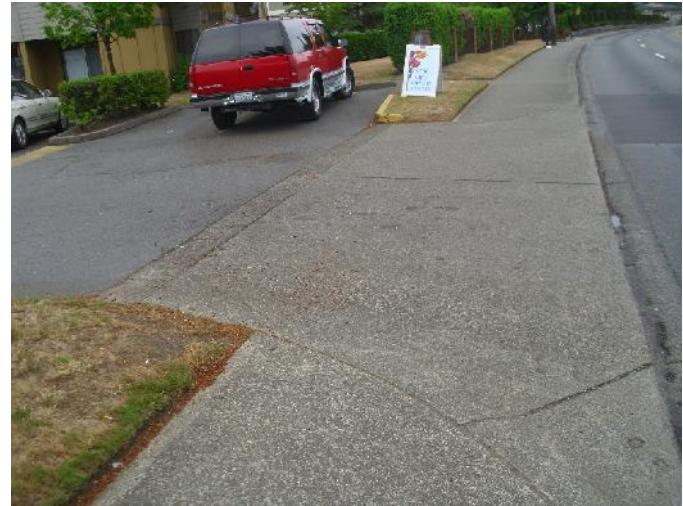
02 View of representative access drive and municipal sidewalk

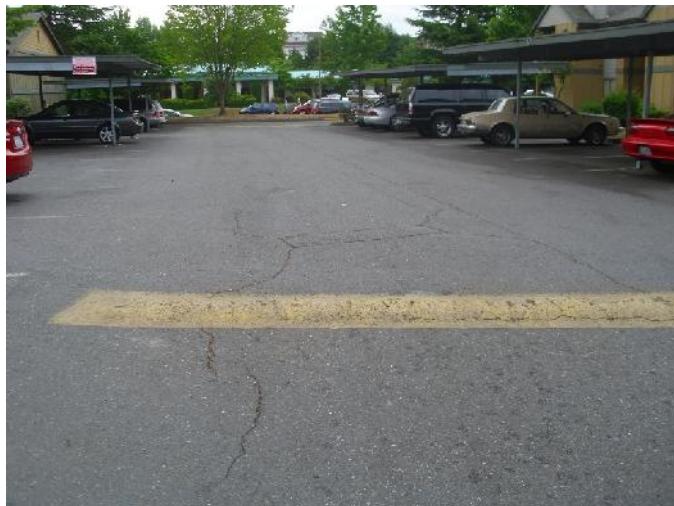
03 View of representative paving

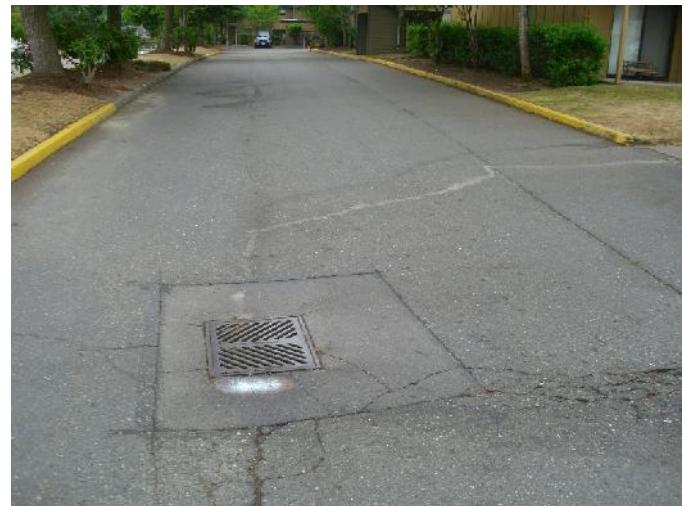
04 View of representative storm drain, paving and curbing

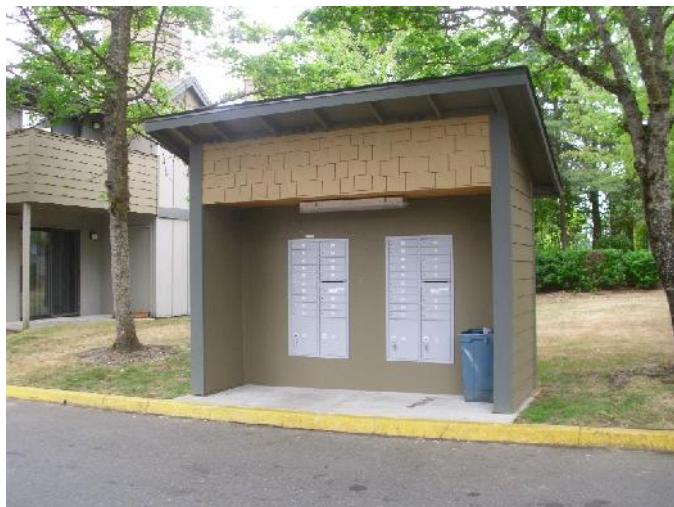
05 View of representative mail station

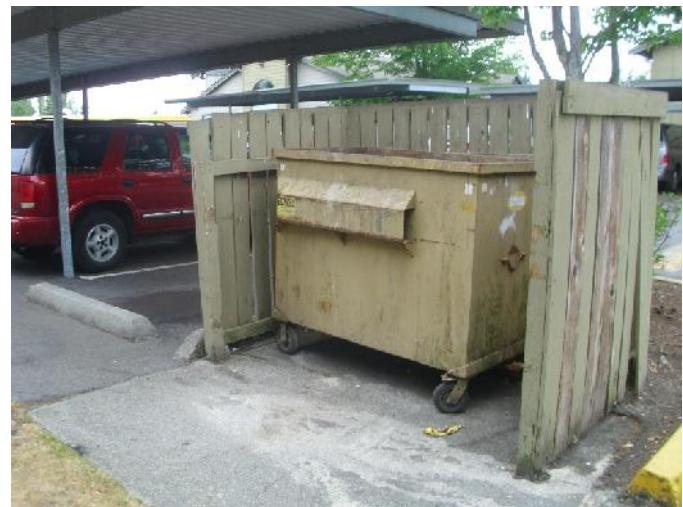
06 View of representative dumpster enclosure

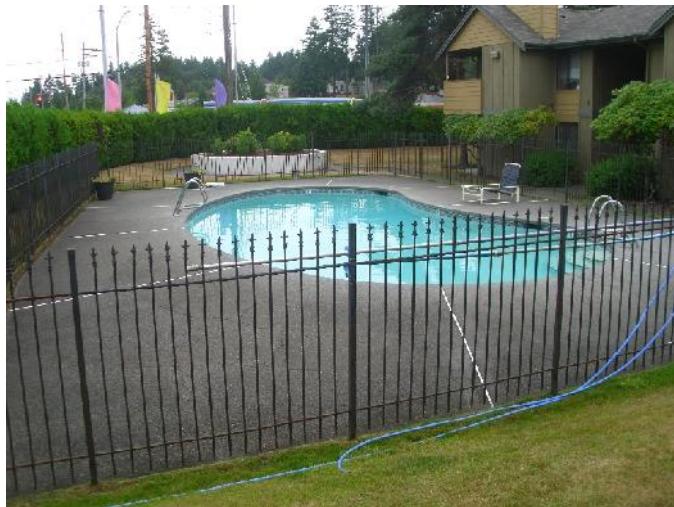
07

View of swimming pool and fencing

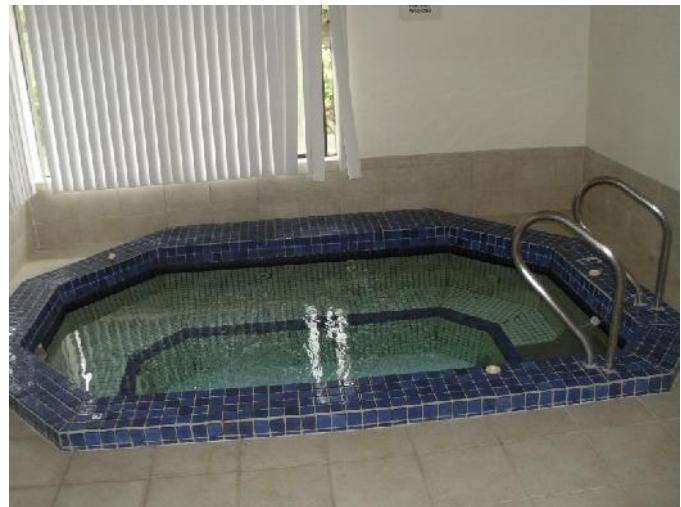
08

View of Spa

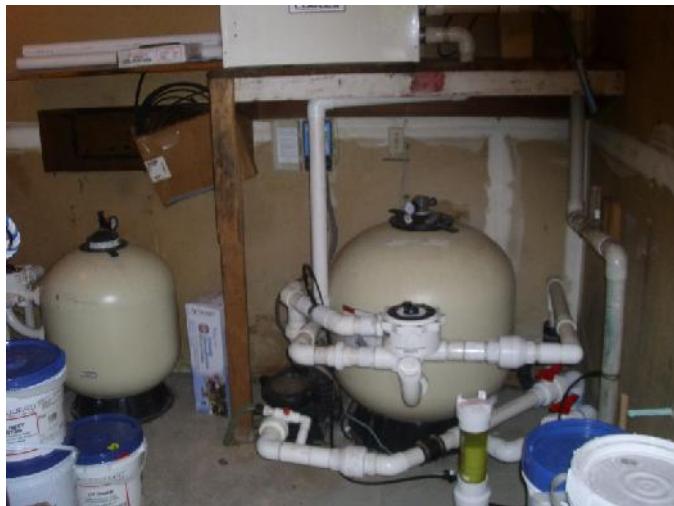
09

View of pool and spa equipment

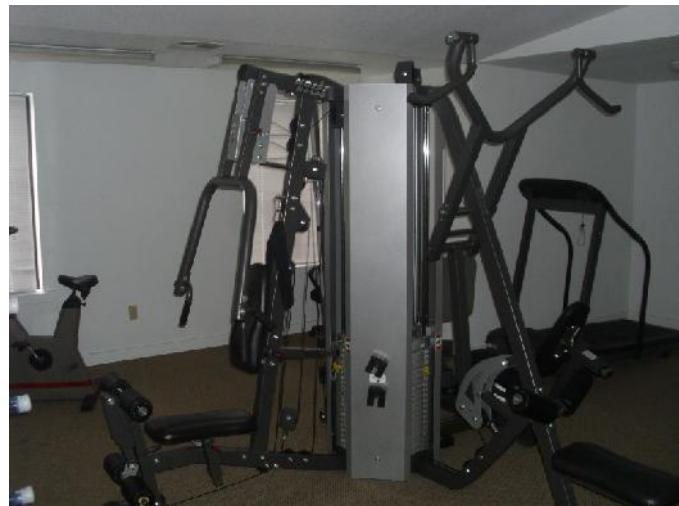
10

View of fitness center

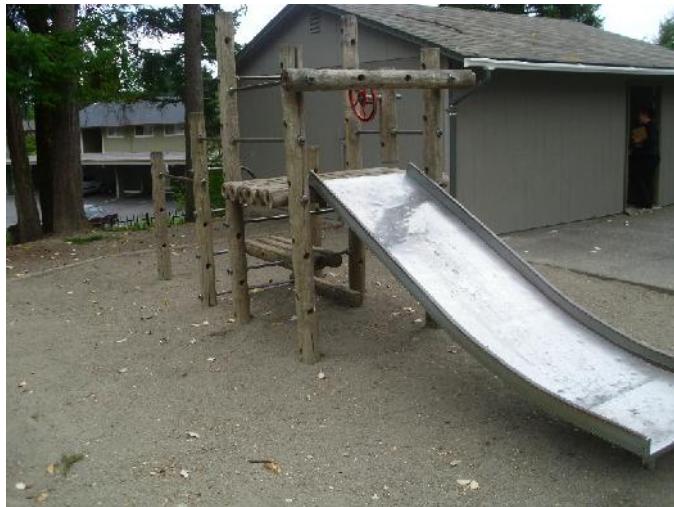
11

View of playground

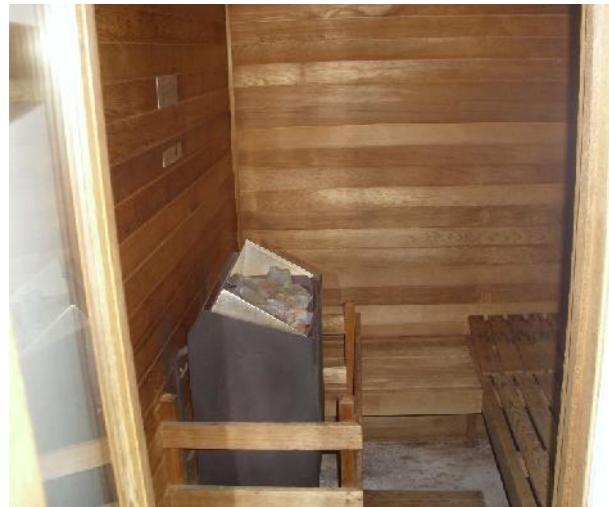
12

View of Sauna

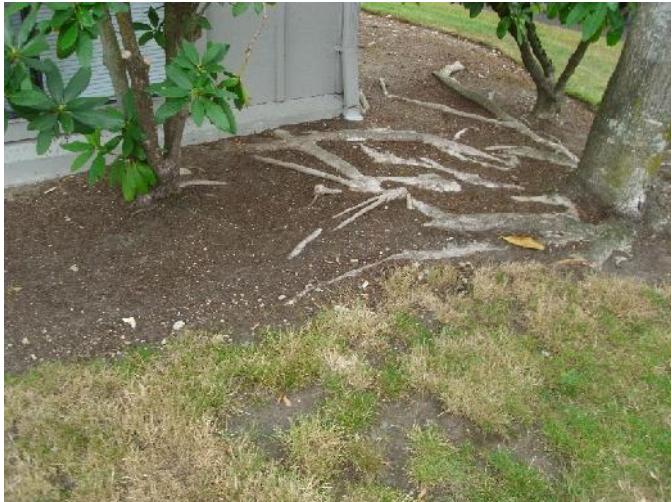
13

View of representative foundation and encroaching tree roots

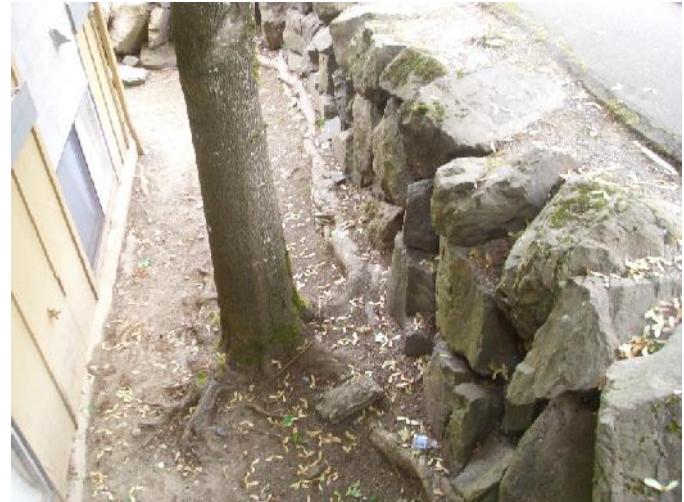
14

View of representative retaining wall and tree too close to building foundation

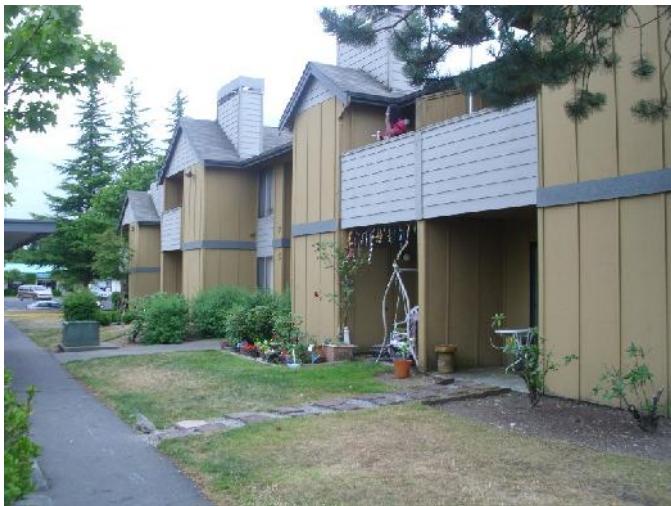
15

View of representative front building facade

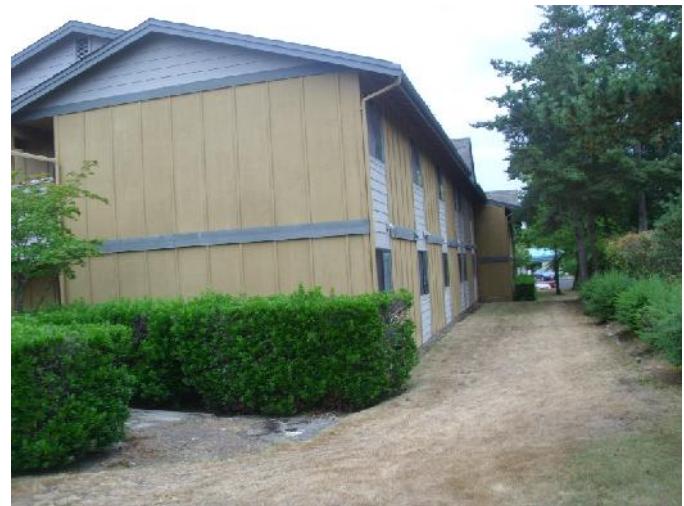
16

View of representative rear building facade and landscaping

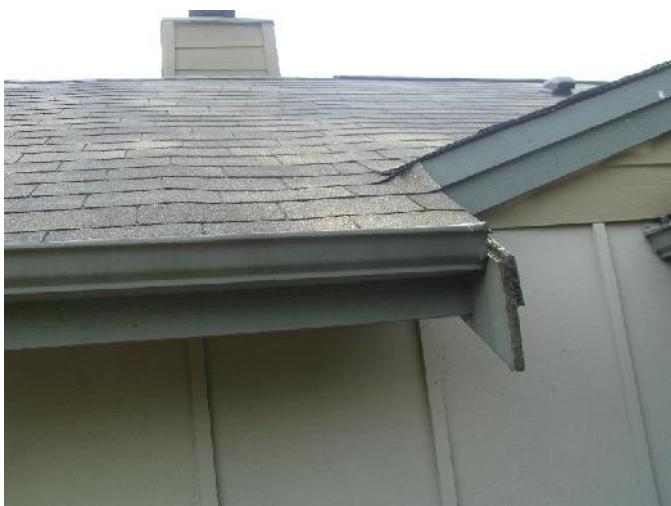
17

View of representative roofing

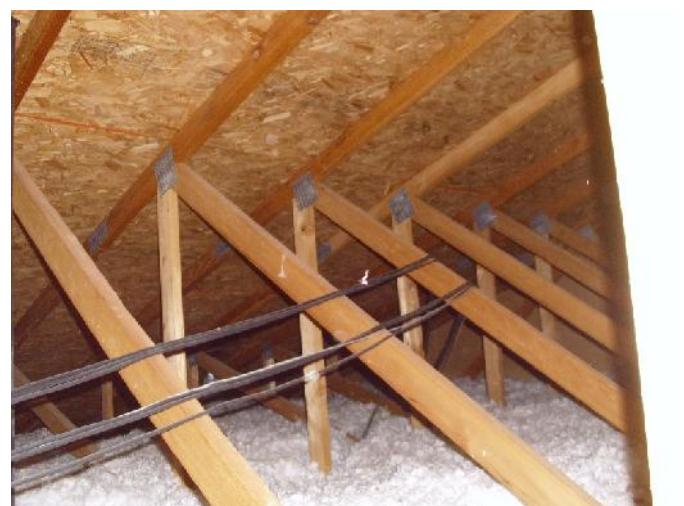
18

View of representative attic space

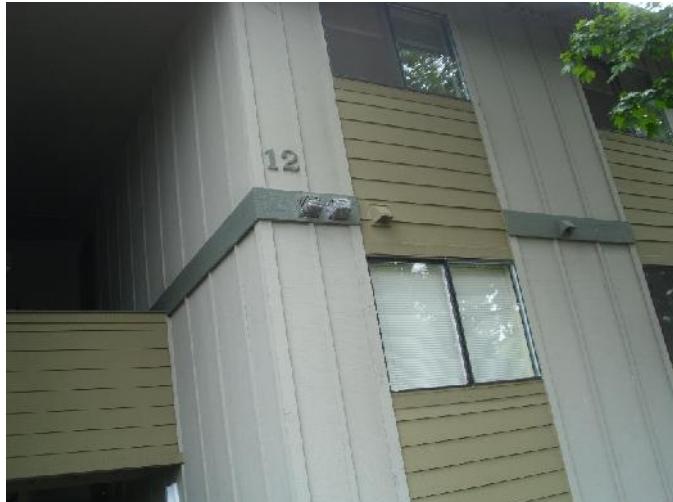
19 View of representative siding, window and building mounted unit number placard

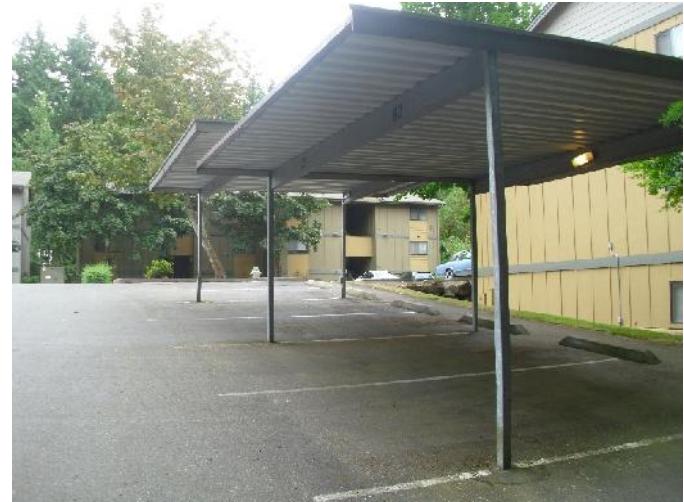
20 View of representative carport and paving

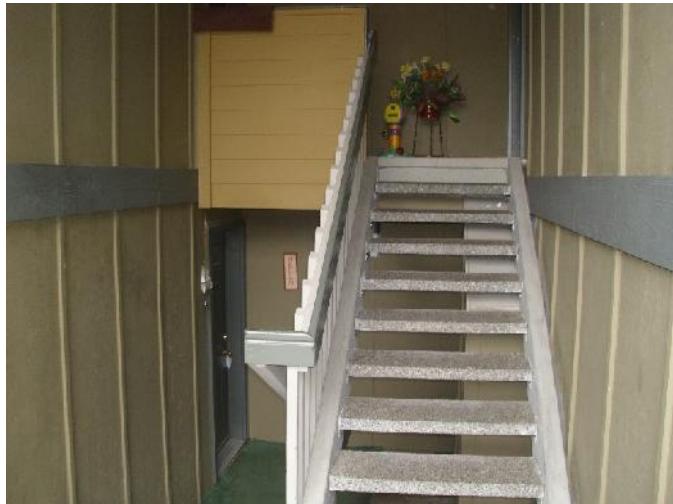
21 View of representative exterior stairway

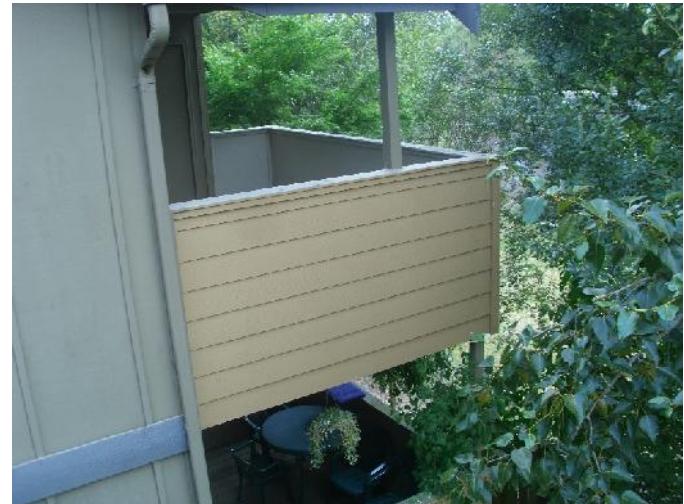
22 View of representative balcony

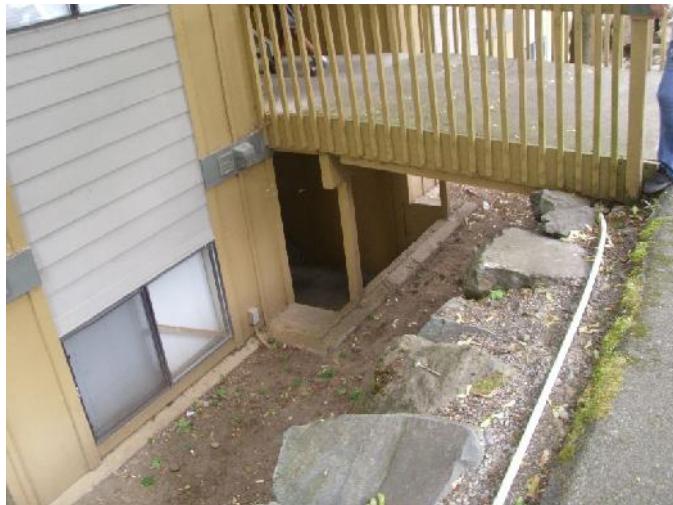
23 View of representative access bridge

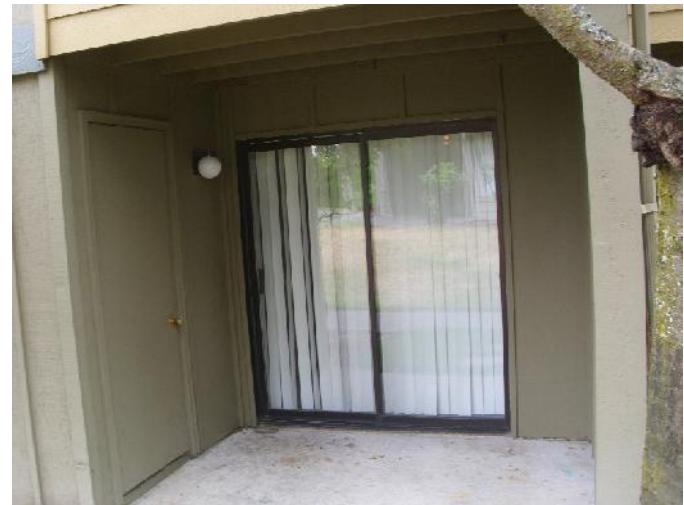
24 View of representative patio and sliding glass door

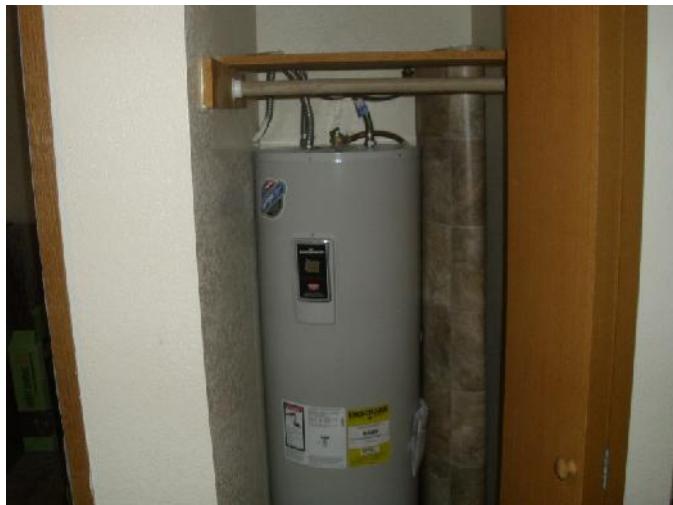
25 View of representative domestic water heater

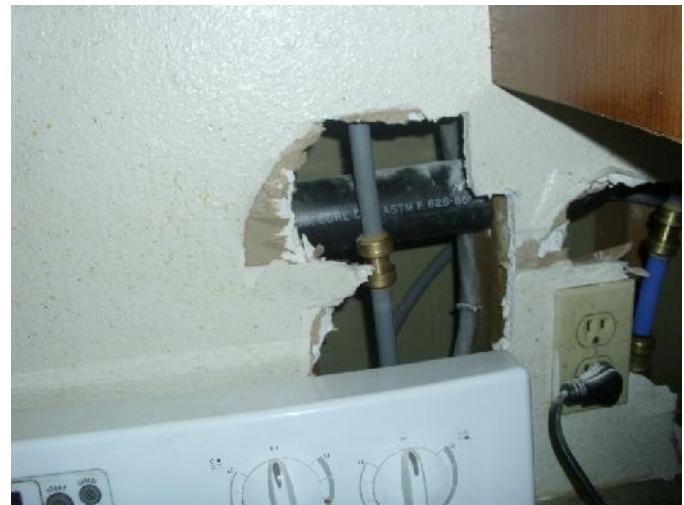
26 View of representative plumbing distribution and waste piping (recently repaired polybutylene leak)

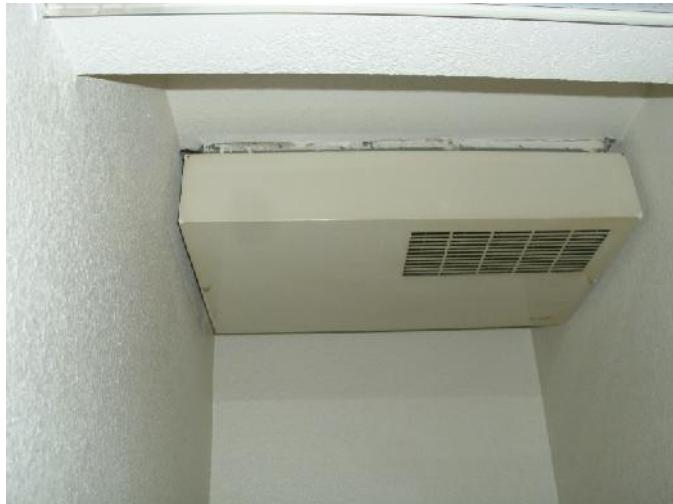
27 View of representative apartment unit ventilation fan

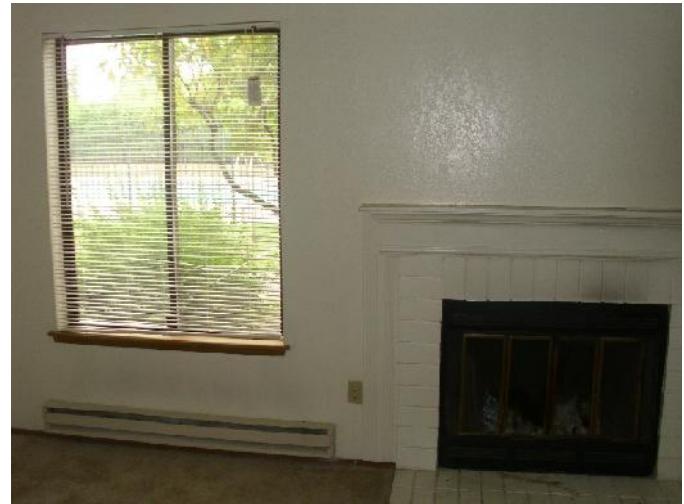
28 View of representative electric baseboard heater, fireplace and window

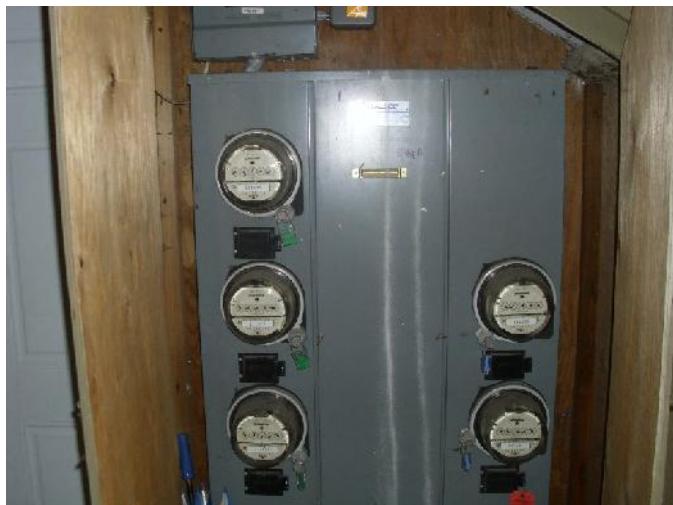
29 View of representative electric meters and main disconnects

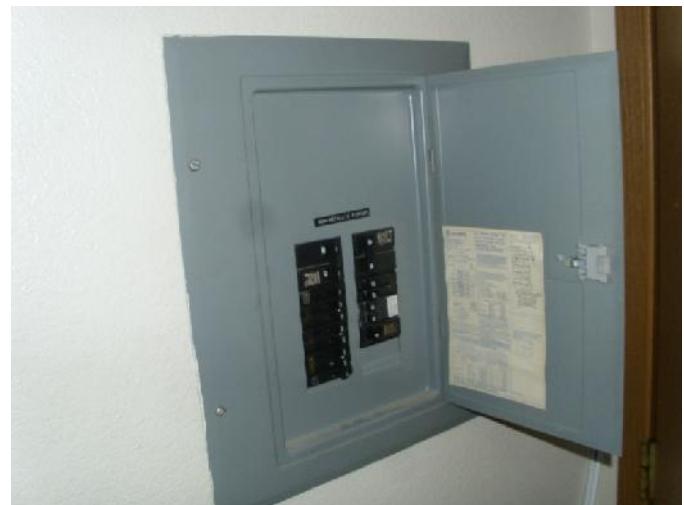
30 View of representative apartment unit breaker box

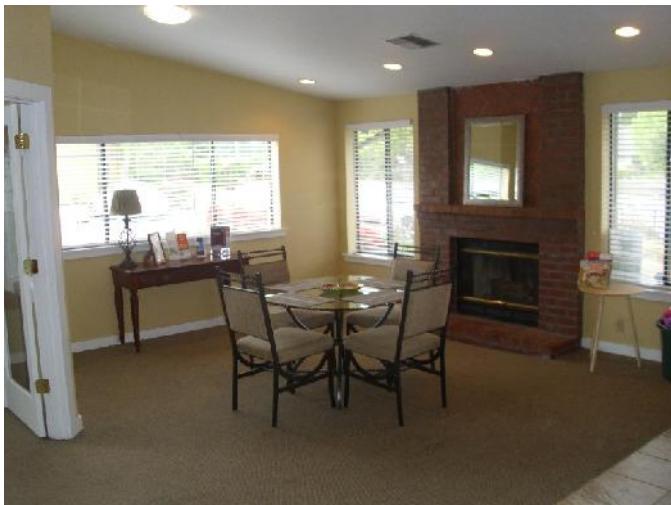
31 Representative view of leasing office

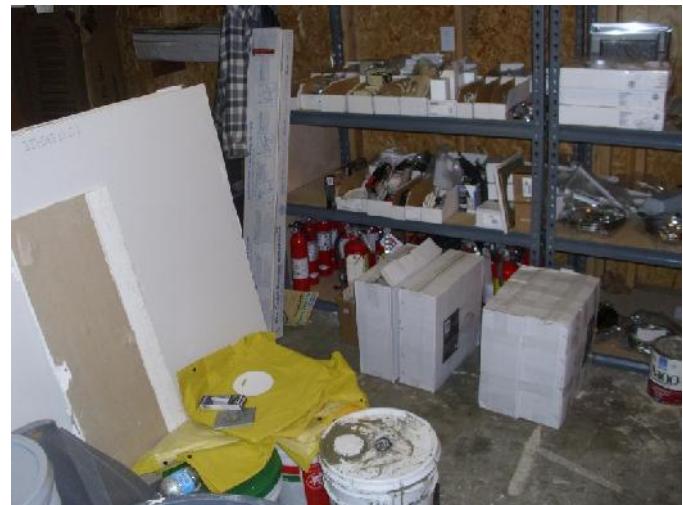
32 Representative view of maintenance shop

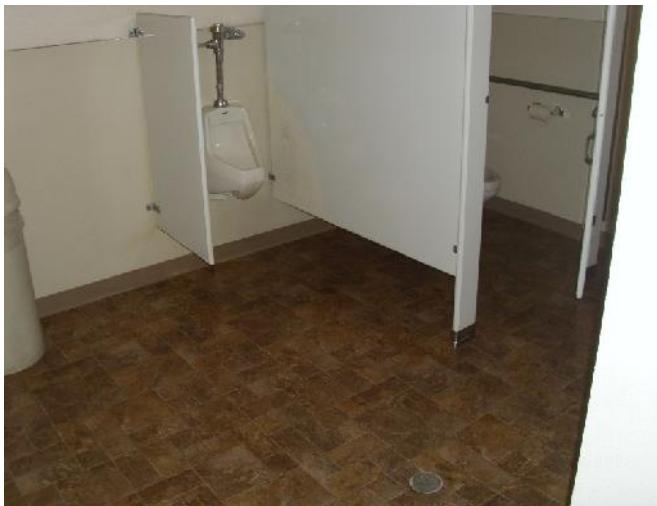
33 View of representative leasing office restroom

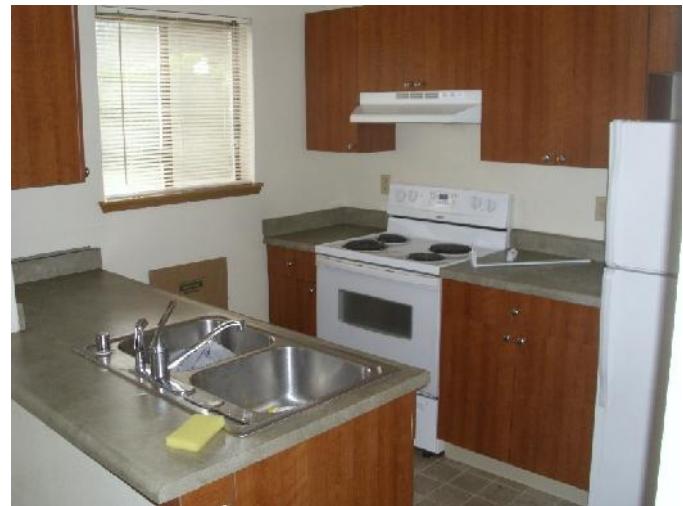
34 View of representative vacant apartment kitchen

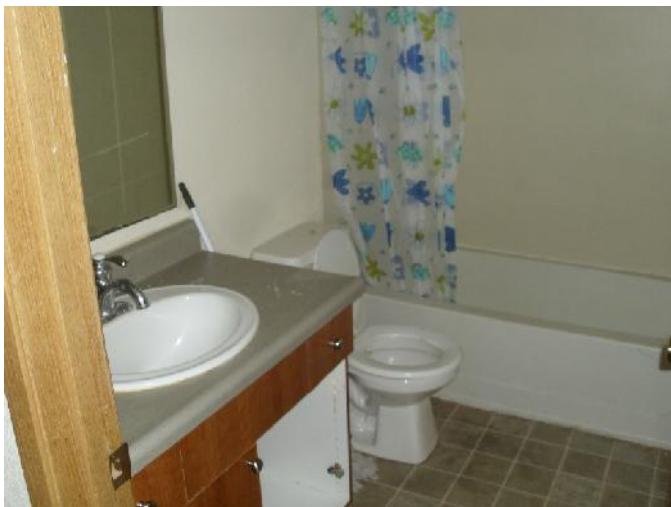
35 View of representative vacant apartment bathroom

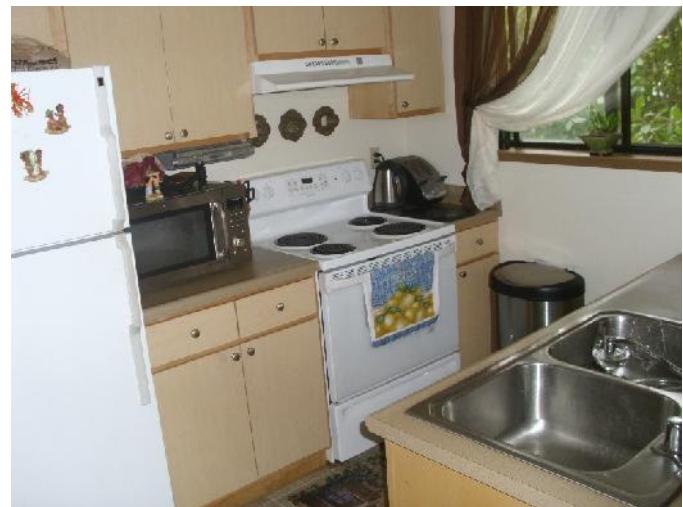
36 View of representative occupied apartment kitchen
